6 National Dam Inspection Program.  
Liberty Dam, Upper Chesapeake Bay  
Basin, State of Maryland, Baltimore  
and Carroll Counties (NDS-MD-3).  
Phase I Inspection Report.

LIBERTY DAM

## PHASE I INSPECTION REPORT

Name of Dam: LIBERTY DAM  
State & State Number: MARYLAND - MD-3  
County: BALTIMORE & CARROLL  
Stream: NORTH BRANCH PATAPSCO RIVER  
Date of Inspection: August 1, 1978

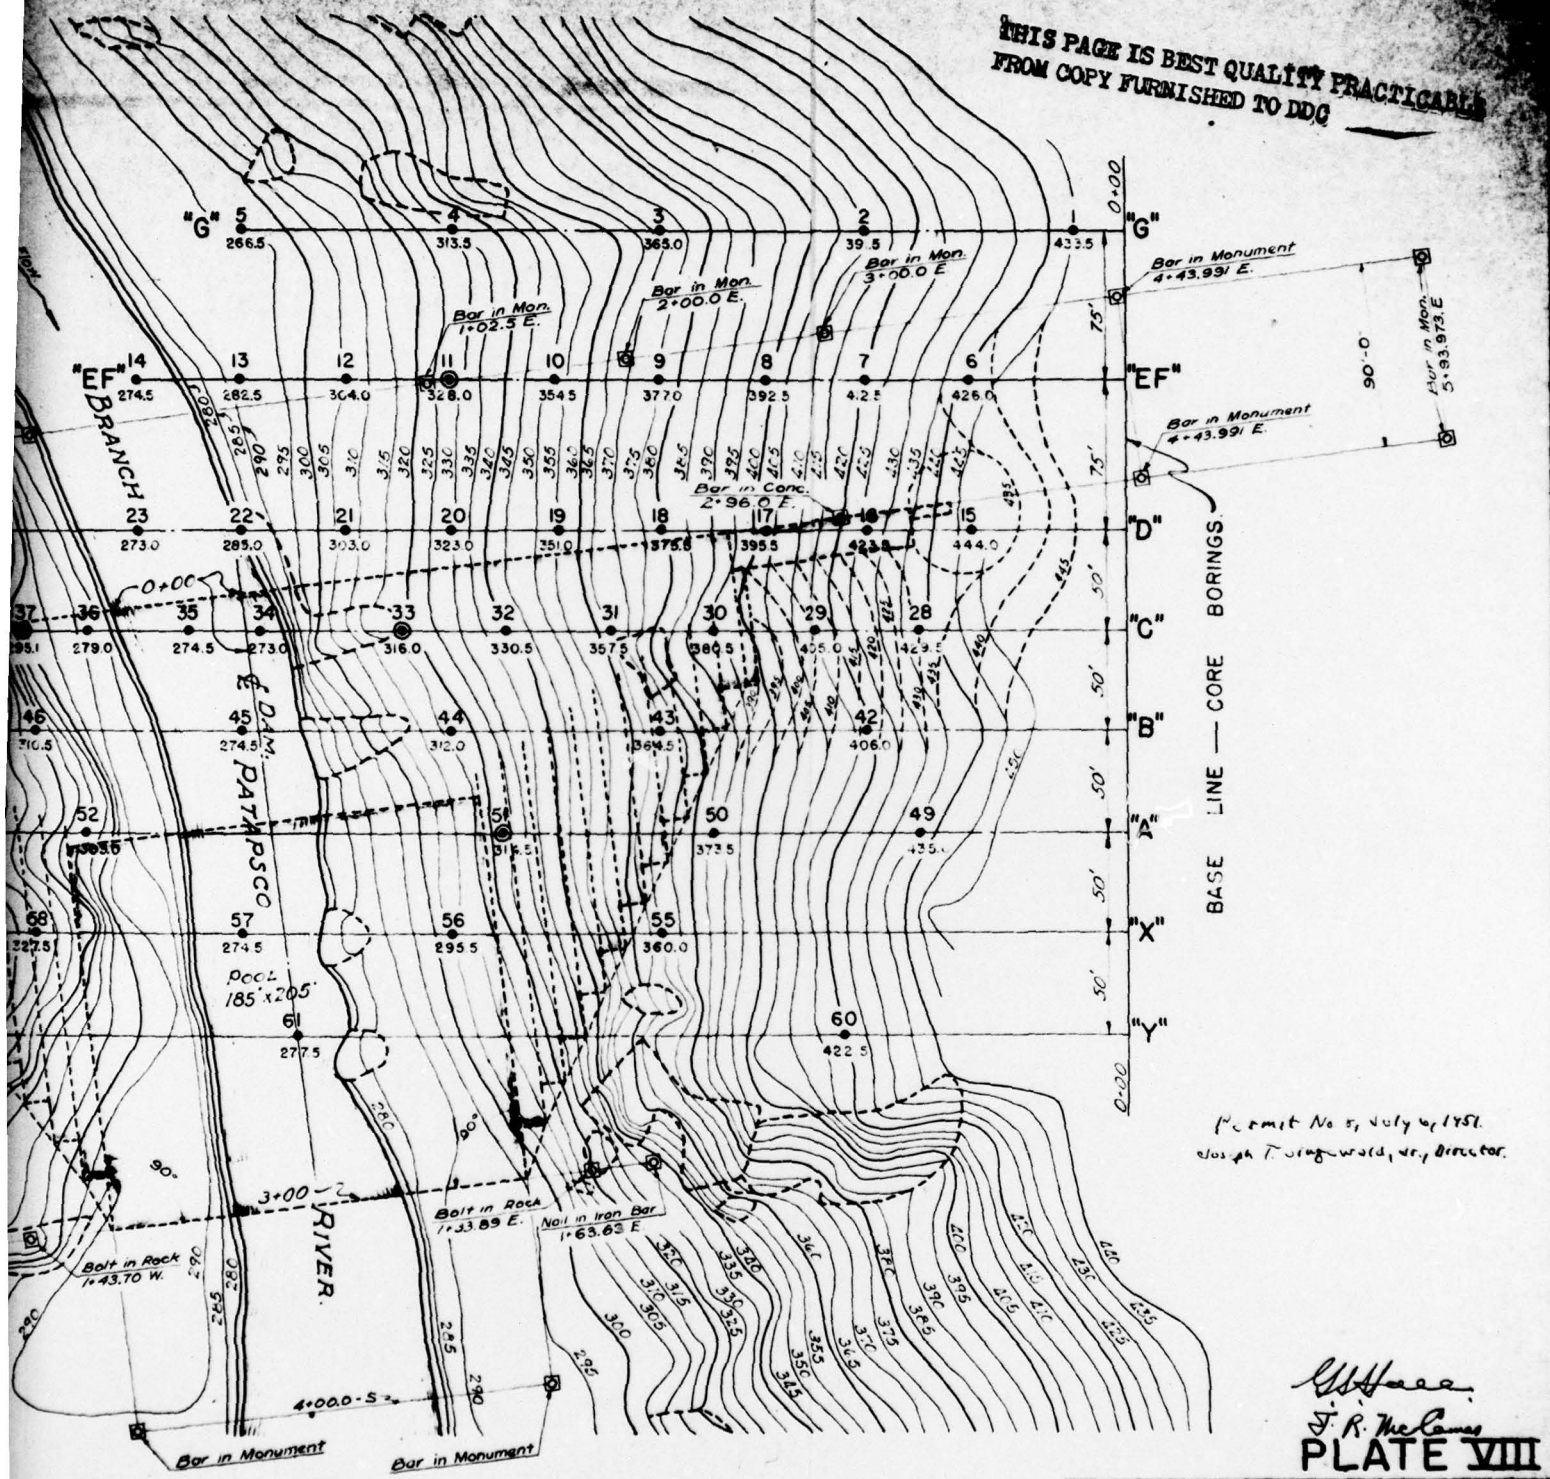
*J.R. McCombs*  
**PLATE VIII**

Borings were taken at approximately 50 feet centers over the foundation area of the dam (Plate VIII, Appendix D). The concrete used in the structure was classified as Class 1 to Class 5, with 28-day compressive strength varying from 4,000 to 2,000 psi. The base of the abutments and the inner core of the spillway (Plate X, Appendix D) are Class 5 concrete (2,000 psi). The outside 4 feet of the spillway is Class 4 concrete (2,500 psi) and the walls and slab of the abutments have Class 2 concrete (3,500 psi). Other classes of concrete were used for the parapet and the intake tower.
